Manhole Inspection Summary

Manhole # S07SS_026MH

Insp Date: **1/29/09 10:51 AM**

Location Address: **EDGEWOOD AVE**

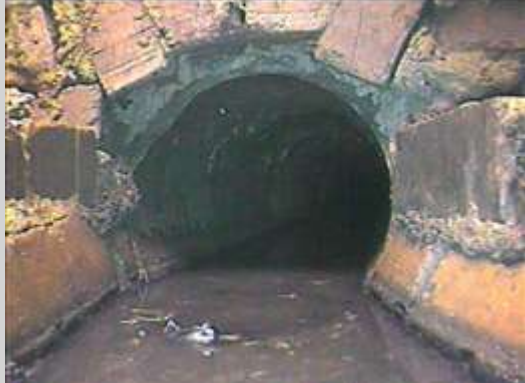
9 O'Clock Inflow

8 in. Circular Gravity Sewer

Pipe In @ 9 O'Clock

Pipe Material: **Clay** ☐ Pipe Lined

Infiltration: **None** Pipe Seal Cond: **Sound**
